Type 14 Nambu Toriimatsu Factory Change Pointsⁱ

By Dan Larkin

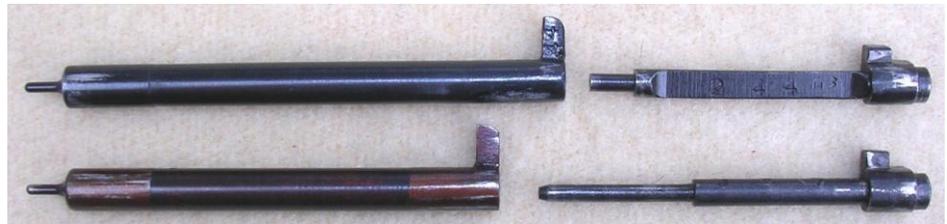
The next major firing pin design change occurred in July 1942 (17.7) when the firing pin was shortened from 73mm to 65mm for a longer striker fall. The firing pin guide length was correspondingly changed to a longer 54mm, and, the guide shape was also changed from flat sides to round sides (see

image). Also, the firing pin numbering changed from the tail to the barrel. While the firing pin had subsequent

modifications, the firing pin guide did not change shape again with the round version lasting until the end of standard production. Both parts were number-matched to the individual pistol as before (pin numbered on the barrel; guide numbered on the side). Unnumbered firing pins and firing pin guides found in pistols during this period are replacements for the original parts. During March 1944 (19.3), the firing pin guide matching serialization was eliminated.

17.7 – 19.3	54mm round – with numbers	73,000
	19.3 – Late 20.6	54mm round – without numbers	47,000
Trigger Pin	16.10 – 18.1	Pin protruding with exposed peened ends	14,000

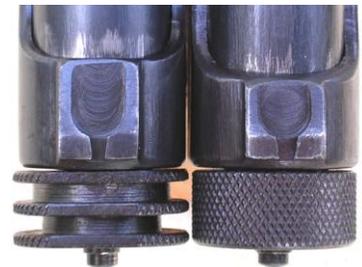
In December 1943 (18.12), the rear frame design supporting the rear sight base decreased in length about 1/10" (see image). In 20-date production, a few frames with the longer rear sight base have been noted. These later-dated frames with the longer rear sight bases may be earlier production frames put into use as pistol part stocks were depleted.

18.2 – Late 20.6	Pin ends ground flush with trigger housing	109,000
Rear Sight Housing	16.10 – 18.12	Length 0.65”/0.69”	57,000
	18.12 – Late 20.6	Length 0.55”/0.59”	66,000
Cocking Knob	16.10 – 18.12	Two wide grooves	58,000

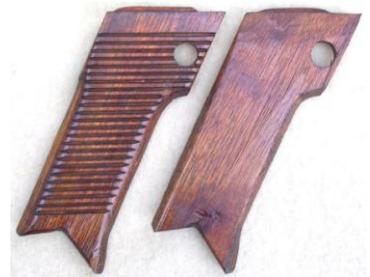
One of the most recognized Toriimatsu Factory production changes happened in November 1944 (19.11) with the replacement of the 24-groove or serrated grips, which are only found in Toriimatsu production, with grips that are flat-sided or smooth – Nambu collectors refer to them as “slab grips” (see image). Curiously, the phase-in of this grip changed happened in a series of stages/blocks.

The first 300-400 pistols in 19.11 had grooved grips. They were followed with a block of 700-800 pistols with the new slab grips. Then, a block of 800-900 pistols using the old 24-groove grips reappeared. Finally, the slab grips returned a second time and were then used for the remainder of Toriimatsu Factory production. With around 10,000 examples available to find, the Type 14 with slab grips is another basic collector variant.

16.10 – 19.11	24 grooves	113,000
	19.11 – Late 20.6	“Slab Grip”	10,000
“Last Ditch”	Late 20.6 – 20.8	Dated/numbered frames with any combination/style parts	1,200
