## Transitional Original Configuration Variation Type 14

By Dan Larkin

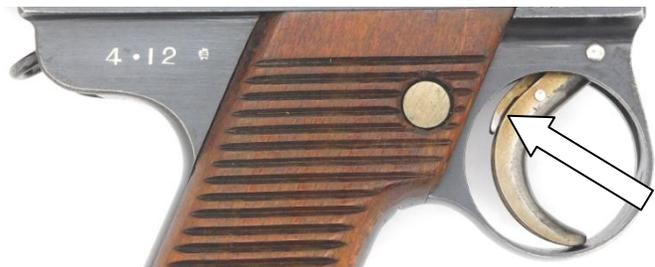
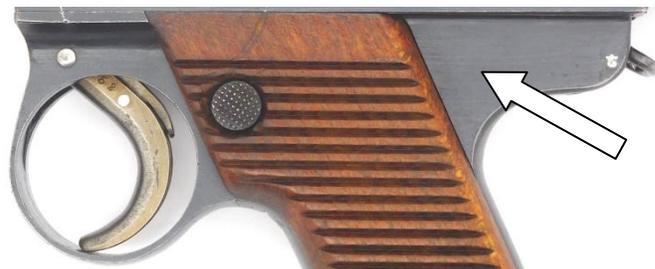
- When viewing a pistol's right side, look at the right side of the trigger and at the trigger guard just behind the trigger. Original trigger back edges carry the trigger curve to the top. Modified triggers have more back edge material to contact the installed magazine safety block extension. Modified trigger guards are machined to accommodate the installed magazine safety block. If it is an original trigger style, the pistol may be an Original Configuration example.
- When viewing a pistol's left side, look for the absence of a "B" position inspection mark (left side frame flat near grips). Modified pistols were stamped in the B position with the mark of the modifying factory. If there is no B position mark, the pistol may be Original Configuration.

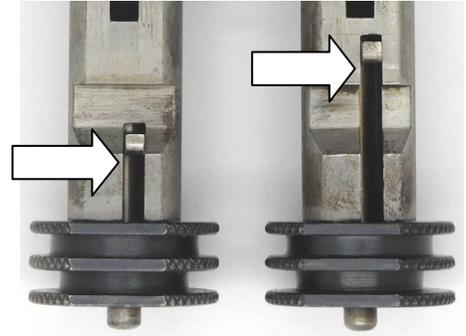
- If both of the two previous observations are positive, look at the underside of the bolt after pulling back on the cocking knob. Original bolts have a very short slot for the striker tail (around ½" + or 14mm), while modified bolts have a longer slot (around 1" + or 27mm). If the slot is the short version, the pistol is an Original Configuration example.

- Bolt underside: See the above image and explanation. The bolt slot length is the definitive way to externally tell if the pistol has the original design internal parts.

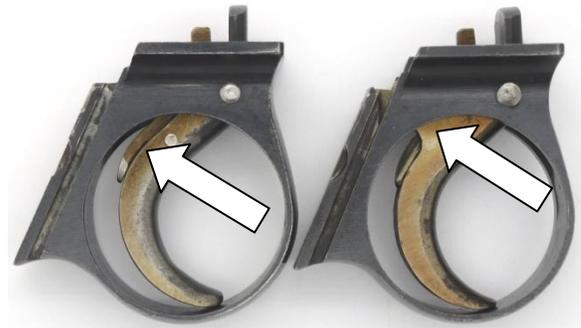
- Trigger right side: original on left; modified on right with extra metal to contact the magazine safety block extension. Note: An original trigger looks exactly the same on the right side and on the left side. The sides on modified triggers are different.

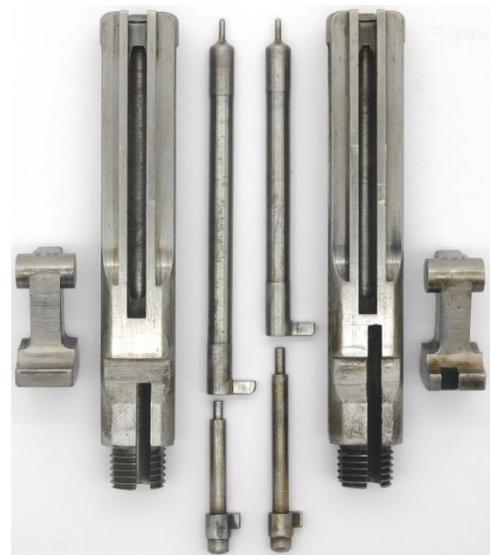
- Internal parts -- Bolt, striker, striker spring guide, locking block comparisons: left side parts are original un-slotted locking block, short slotted bolt, long 86mm striker, and short 35mm striker spring guide; right side parts are modified shorter 73mm striker, longer 47mm striker spring guide, long slotted bolt, and slotted locking block. Again, the bolt slot lengths are easily checked by looking at the underside of the bolt.

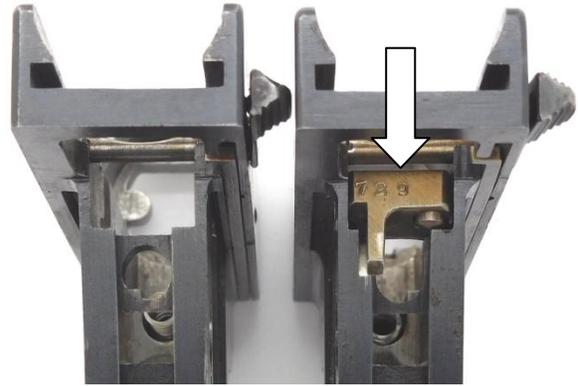
- Magazine safety block installation: original on left; modified on right with machined frame and installed block.

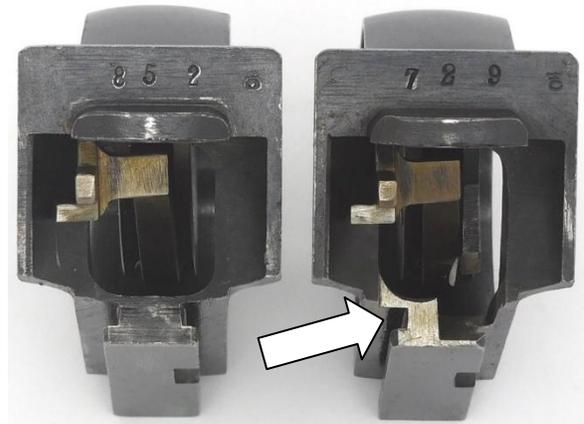
- Trigger guard machining to accept magazine safety block: original on left without machining; modified on right with machining.
